CENTRAL INTELLIGENCE AGENCY

INFORMATION REPORT

SUBJECT Batumi Harbor

DATE DISTR. 6 April 1953

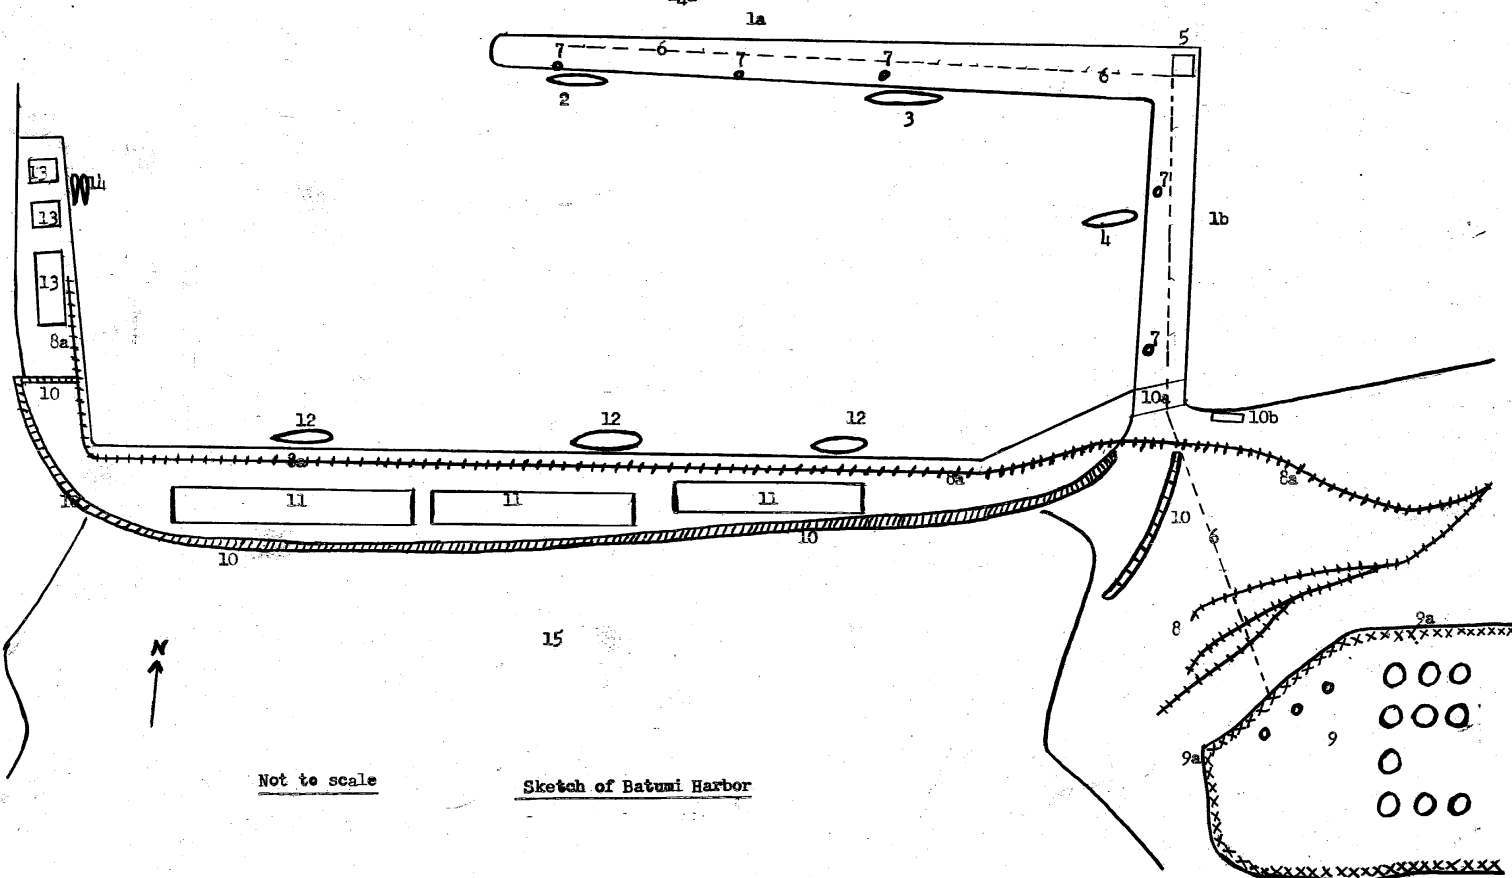
Legend to Sketch

- 1a. Main jetty, revetted with stone flags on the sea front and reinforced with sheet piling on the harbor side. The upper side of the jetty is paved. The jetty is about 450 meters long, about 50 meters wide, and about 5 meters high.

- 1b. Jetty, about 200 meters long; for other dimensions see 1a.
2. Berth 25X1
3. Soviet tanker, of about 16,000 GRT 25X1
4. A Soviet destroyer docked at the jetty for fueling.

5. Watchtower, about 20 meters high and permanently manned by Soviet soldiers. The tower was equipped with a searchlight.
6. Oil line which ran from the refinery (9) to the marshaling yard (8) as an overhead line, ran below across the marshaling yard, and then continued to the jetty as an overhead line.

7. Taps on oil line.
8. Marshaling yard; heavy day and night traffic of tank cars was observed. The number of spurs was not determined.
- 8a. Harbor spur track from the marshaling yard.

9. Fuel depot. It was impossible to determine the exact number of fuel tanks. The depot was dirty and neglected.
- 9a. Barbed wire fence around the depot.

10. A brick wall, three or four meters high. This wall runs around the entire harbor; another wall extends around the marshaling yard.
- 10a. Gate leading to the jetty, probably the only one. It was guarded.

- 10b. Living quarters of the Soviet Harbor Guard.
11. Three storage sheds; plain wooden sheds on concrete foundations about one meter above the ground. No cranes were seen.

12. Three Soviet merchant vessels berthed in front of the three storage sheds.
13. Navy arsenal, consisting of a long wooden shed on a concrete foundation and two small workshop sheds. Buoys, anchors, and sheet metal were seen in front of the sheds. Crane installations were not observed. The Navy arsenal area was separated by a low brick wall from the merchant harbor. There was a passage only for the harbor spur track. The Navy arsenal looked rather neglected.

14. Two PT boats at the quay of the navy arsenal. they were obsolete, decommissioned vessels. There were no crews seen aboard. 25X1
15. Batumi town district.
